7000 SERIES MAINFRAME INTERFACE CONNECTOR COVERS

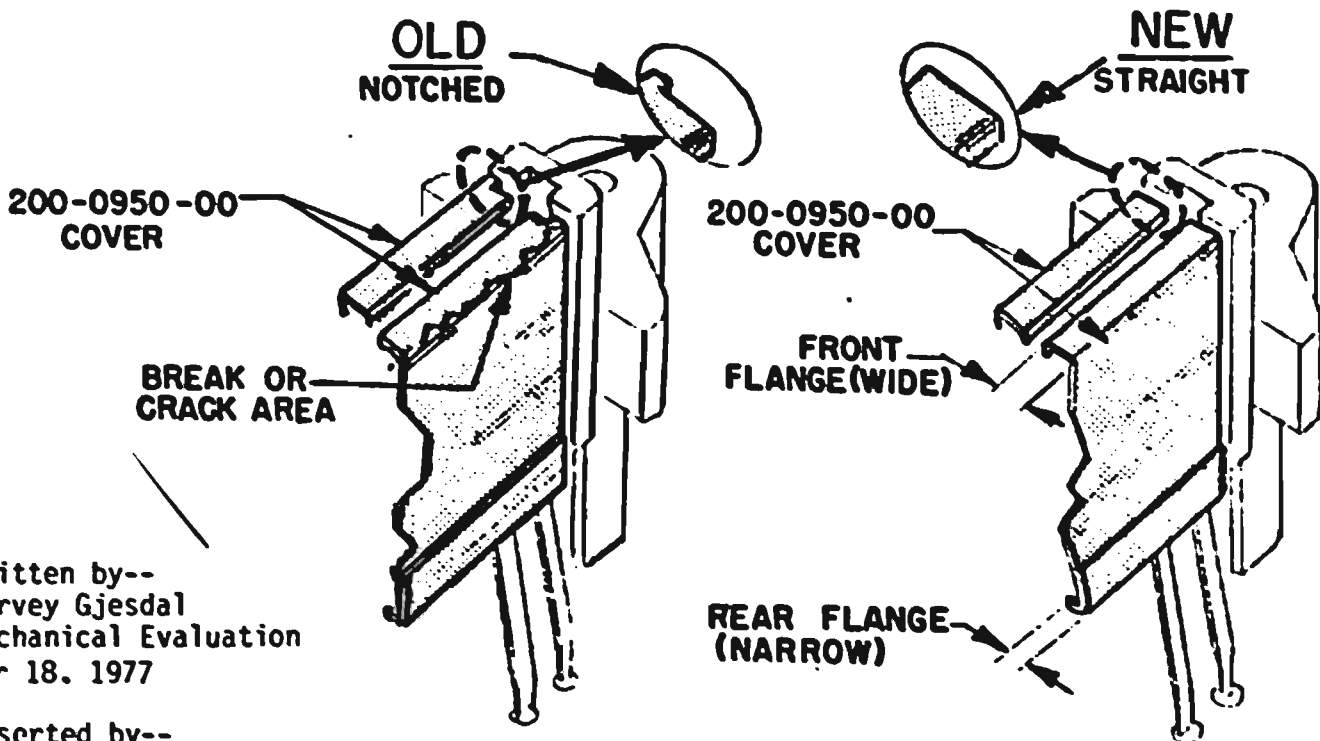
Field failures have shown up on the 200-0950-00 cover for interface connector. Breakage occurs along the front flange (see sketch). Even a slight crack can be serious, causing tension to be released on the contacts with resulting intermittence. This problem was corrected in March 1973 by small dimensional changes and a significant molding process change. The stock of old covers has been destroyed.

Sketch reveals how to distinguish between old and new covers. An adequate supply of new covers is available, PN 200-0950-00. We recommend replacement of all old covers at your earliest convenience.

Cover Replacement

Remove old cover by prying with small screwdriver to unlatch front flange from connector body; start at end.

Install new cover by holding rear flange full length against back edge of connector body while squeezing front flange into latched position on connector body. Front flange may be "zippered" into place beginning at one end.

Inspect by viewing from front. If rear flange shows bulge, remove cover as above and reinstall. If front flange shows bulge, squeeze to complete latching. If front flange extends into circuit board clearance slot, pry lightly to release it to its normal latched position.
