576 STEP GENERATOR INTERMITTENTLY SKIPS STEPS

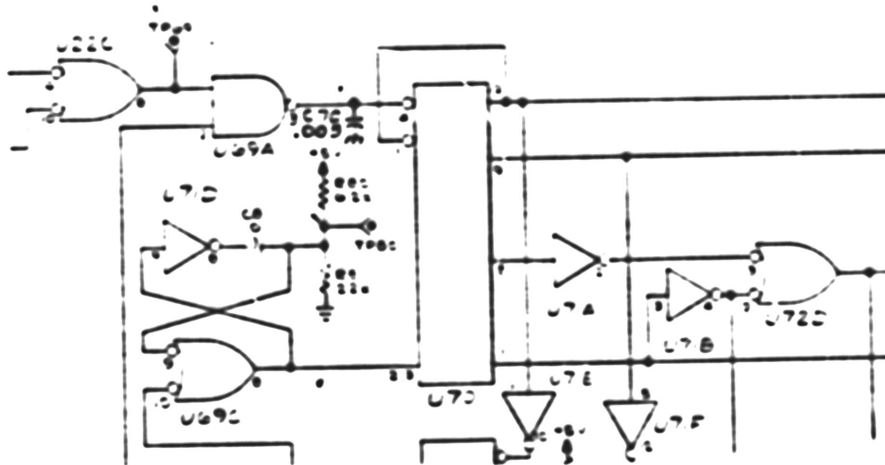
STEP GENERATOR

Manufacturing has found a problem in the 576 whereas the Step Generator would intermittently skip steps. To alleviate the situation, a Modification, M41067 was generated to install a capacitor, C-70 from U70, Pin 14 to ground (see illustration below). This mod was implemented by Manufacturing on all products starting at Serial Number B327878.

Add C70 from pin 14 of U70 to ground.
